**Report No. T121439, Issue 2
December 5, 2011**

COMPRESSION TESTING OF A BUS PLATFORM

Heavy Duty Ramps requested Exova to conduct compression testing of one bus platform. The purpose of this test was to determine the maximum load capacity of the bus platform. Test was performed on November 22nd 2011.

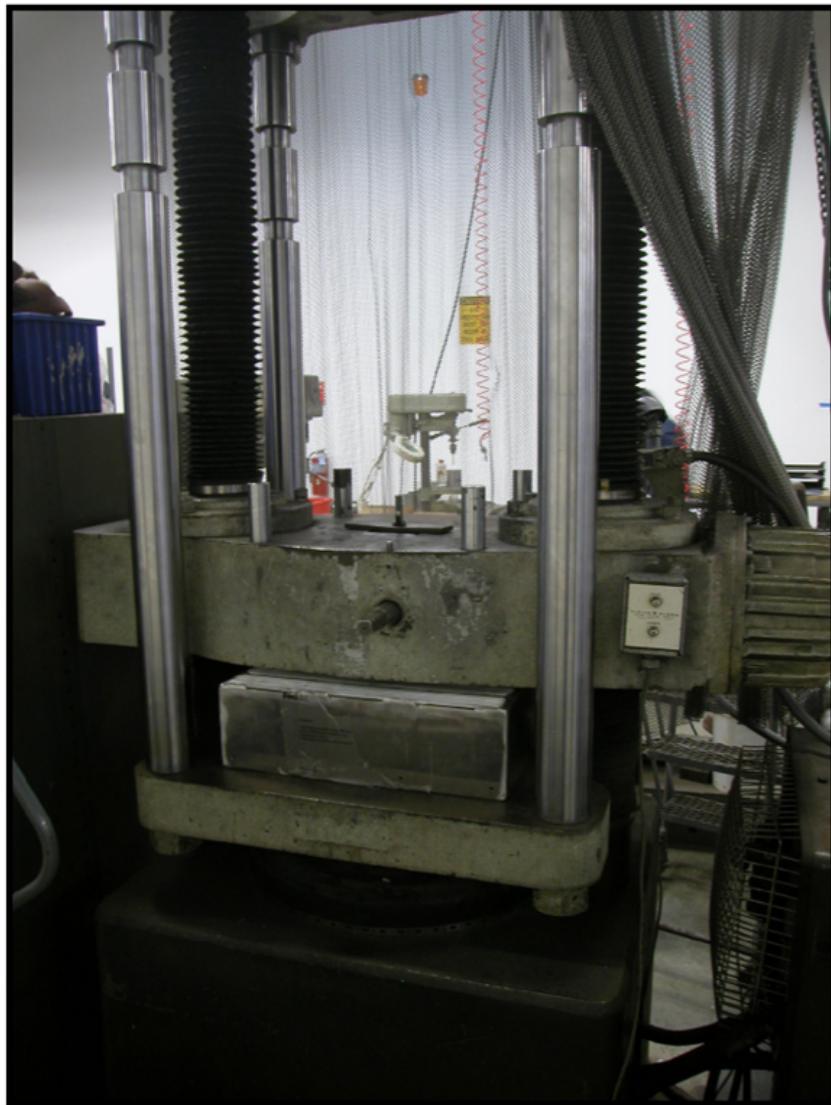
Photograph 1: Compression test setup: Bus platform in test position

The bus platform was compressed with an aluminum plate (length: 20", width: 6", thickness: 1") provided by Heavy Duty Ramps (see Photographs 1-4 for test set-up). The load was applied on the marked area indicated by Heavy Duty Ramps (see Photograph 3). The test area has been marked at mid-distance from the extremity and the middle of the platform.

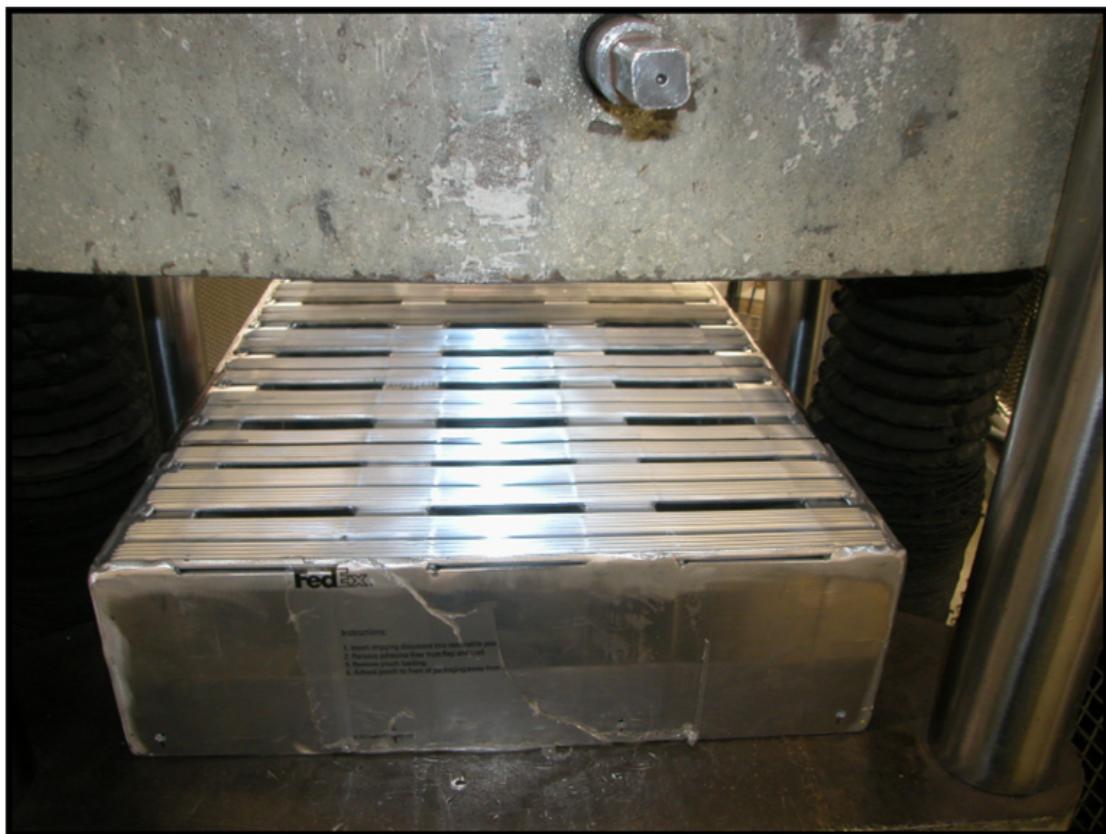
Photograph 2: Compression test setup: Bus platform under the 400kip frame

The compression testing was performed on our 400kip frame. This system is equipped with an Admet controller and a computer interface for test control. The load cell was calibrated on June 2011 and will require calibration on December 2011. The displacement module was calibrated on June 2011 and will require calibration on June 2012.

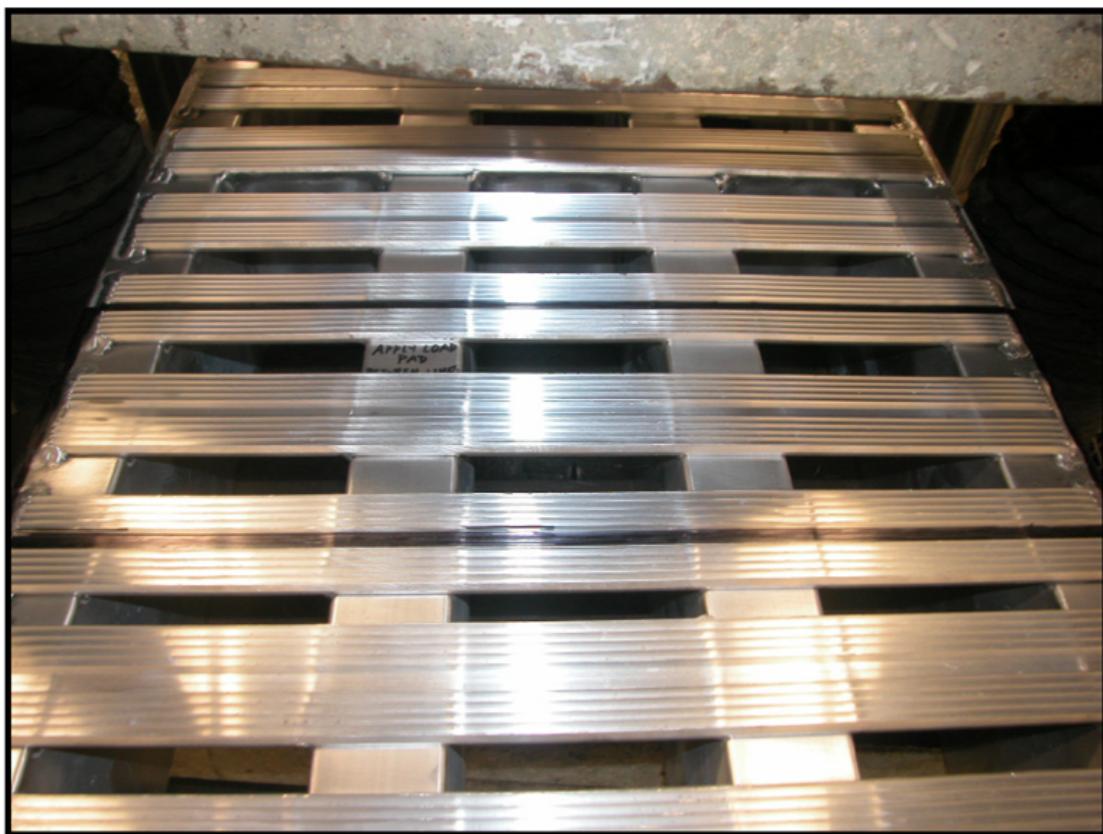
Photograph 3: Compression test setup: Area marked by Heavy Duty Ramps (Black lines) for compression testing

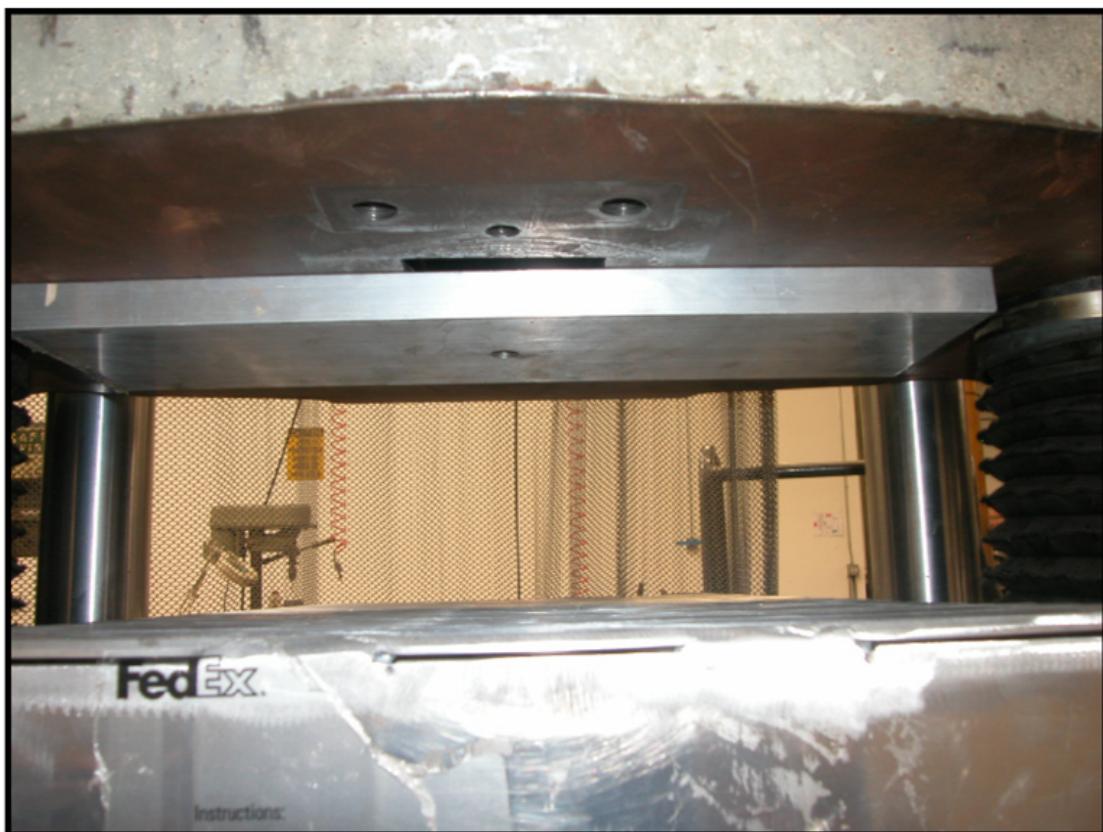
Photograph 4: Compression test setup: Compressive aluminum plate

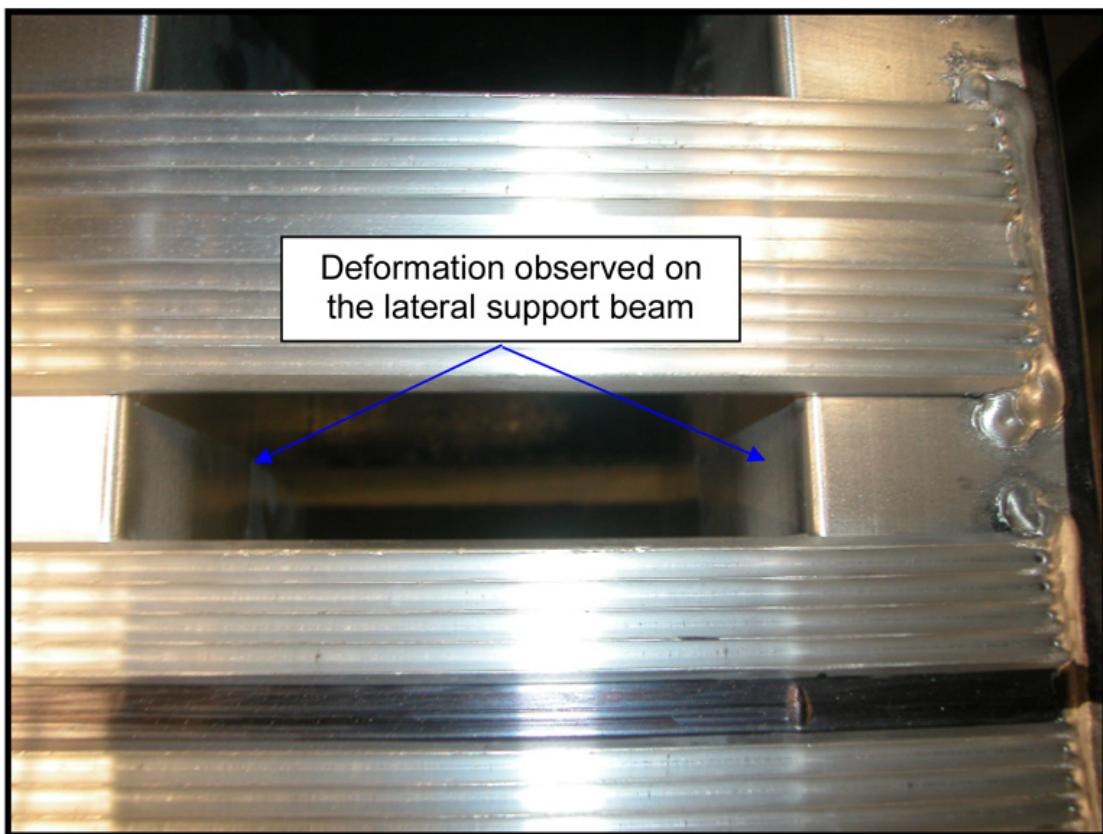
Photograph 5: Deformation of the lateral support beams after testing

Deformations of the lateral support beams were observed (see Photograph 5)

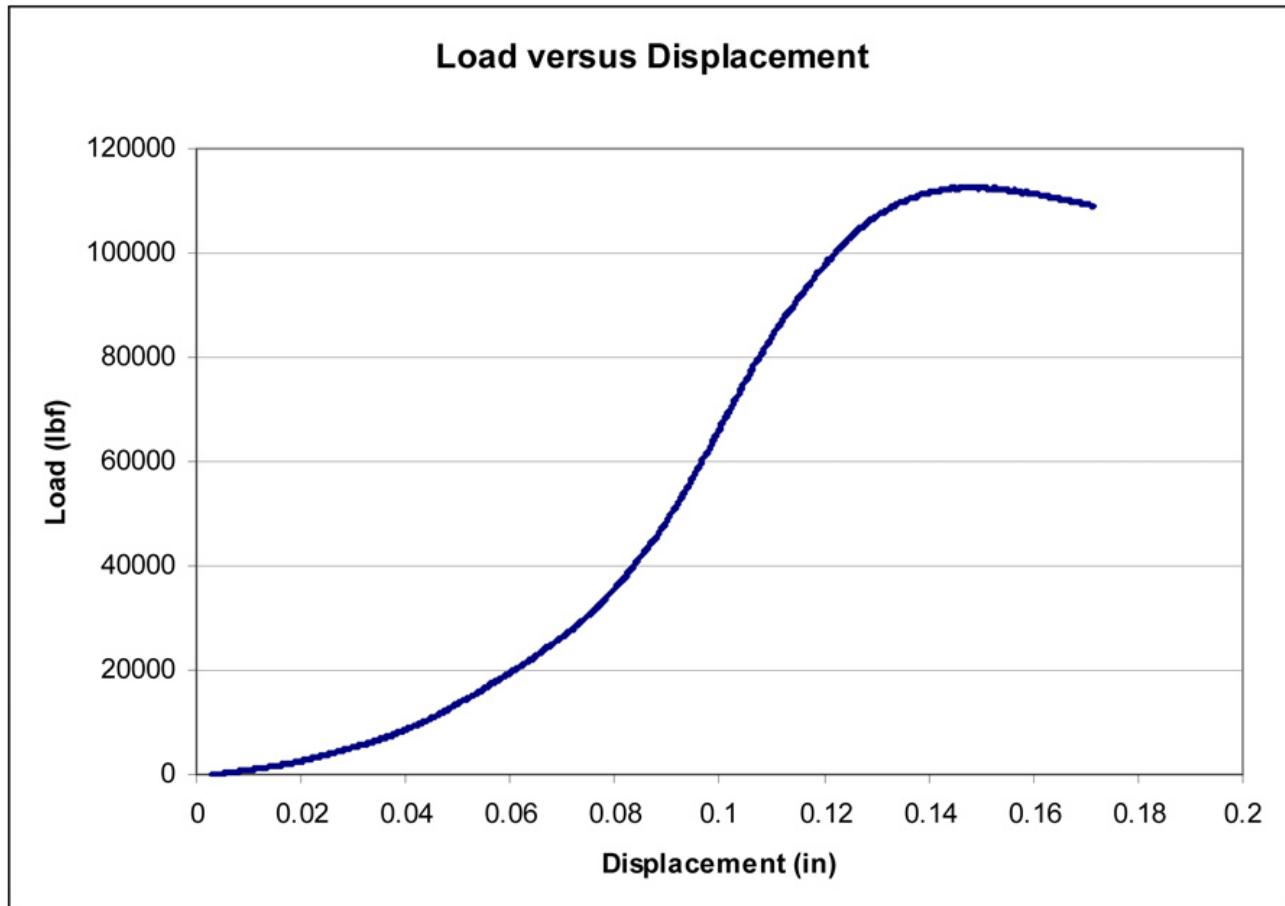
Figure 1: Bus platform: Load versus displacement curve

The maximum load recorded was 112,700 lbf (see Figure 1).
